**Flood Control Project Maintenance
Levee Inspections**
LMA District Cover Sheet
Spring 2019 Levee Inspection Results

Reclamation District No. 0524 Middle Roberts Island

Spring 2019 Levee Inspection Results

Waterway			Bank	Unit Miles
Unit No. 01 San Joaquin River			Left	6.20
	Spring (March - May)	Summer (June - August)	(September - November) Fall	Winter (December - February)
Unit Maintenance Rating (Fall Only)				
Date of Inspection	3/26/2019 - 3/27/2019			
DWR Inspector	Alberto De Leon			
Accompanied By	Zach Jojola DWR

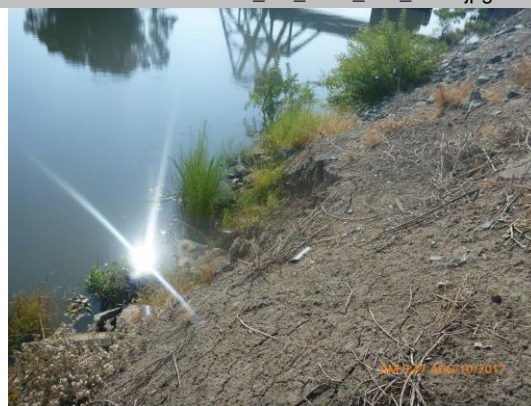
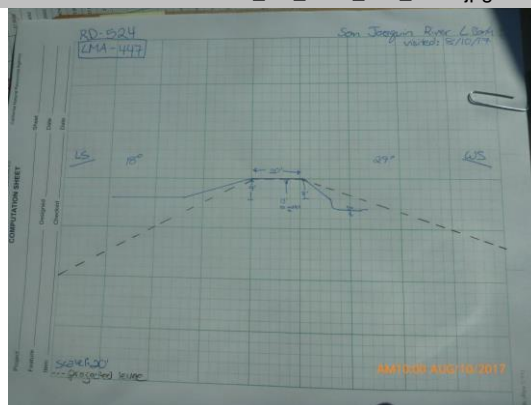
Item	2017 Storm Damage		37.937500 °	37.937500 °								
			-121.335500 °	-121.335500 °								
DWR ID	DWR_RD0524_01_f_2017_153											
Comment Code												
Inspector Comment												
<p>Levee Evaluation Comments</p> <p>Description: Slope protection repairs are needed along the waterside slope due to erosion and riprap displacement from high water. Based upon levee inspections, it was determined the waterside levee slope is eroding, deteriorating, and degrading. The eroded levee sections need to be restored back to design standards to prevent further deterioration and damage.</p> <p>Site ID No: 541</p> <p>Site Designation: LMA-447</p> <p>Repair Type: Erosion</p> <p>Rating: Area of Concern</p> <p>Field Date: 8/10/2017</p> <p>Notes:</p>

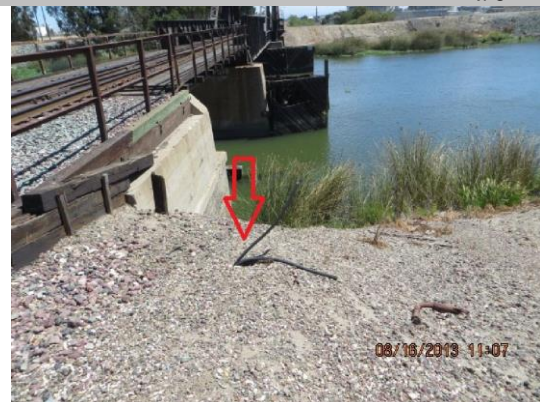
Photo 1 of 1 : UCIP_SP_2019_41463_29717.jpg

Conduit visible on WS shoulder next to bridge abutment. Cable appears to be abandoned.

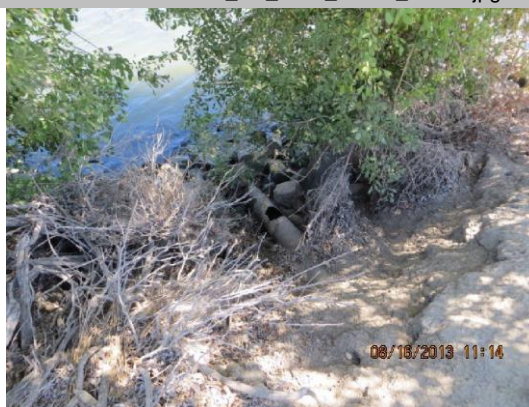
Photo 2 of 2 : UCIP_SP_2019_17571_29718.jpg

Large hole in pipe at WS toe.

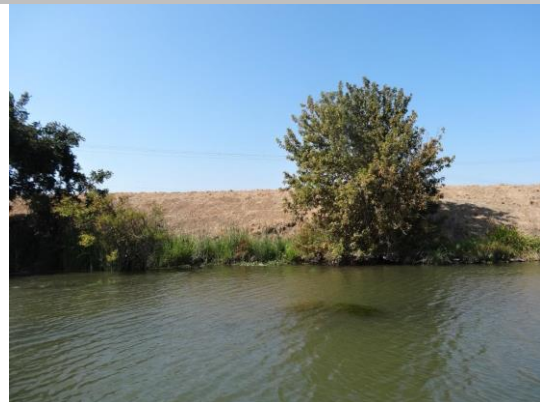
Photo 1 of 2 : SP_2019_RD0524_107_22_20190313_00034.jpg

LM Start	0.83	Rating **	U	Issue No.	22
LM End	0.84	Issue Type +	Ma	Location *	WS
Category	Supplemental			GPS Latitude/Longitude	
				Start	End
Item	DWR Erosion Survey			37.935930 °	37.935930 °
				-121.334133 °	-121.334133 °
DWR ID	RD0524U01RM41.44				
Comment Code					
Inspector Comment					
09/13/2017: No significant change observed.					
07/25/2016: No significant change observed.					
06/24/2015: No significant change observed.					
06/19/2014: No significant change observed.					
08/13/2013: Site was discovered during boat survey. The dense vegetation blocks a clear view of the erosion. Size of erosion site was very roughly estimated. [2017 Site ID:RD0524U01RM41.44]

Front view of the erosion. The tree and vegetation block the view of the site.

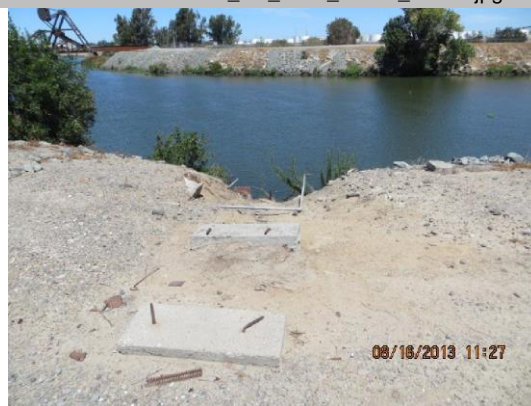
Photo 1 of 3 : UCIP_SP_2019_22724_38442.jpg

Concrete pad for pump mount on WS shoulder.

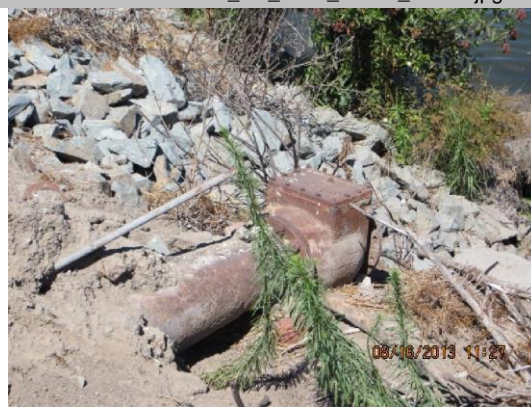
Photo 2 of 3 : UCIP_SP_2019_22724_38441.jpg

Pipe visible on WS slope.

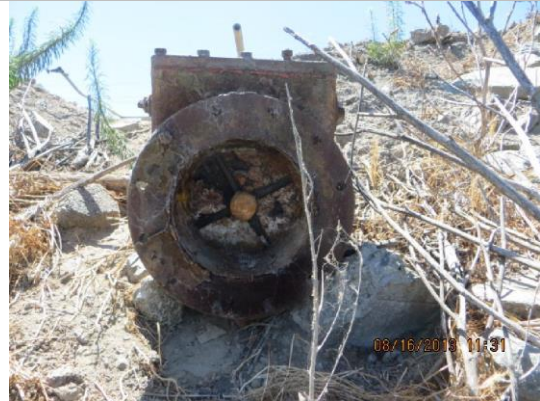
Photo 3 of 3 : UCIP_SP_2019_22724_38440.jpg

One way check valve closed on WS slope.

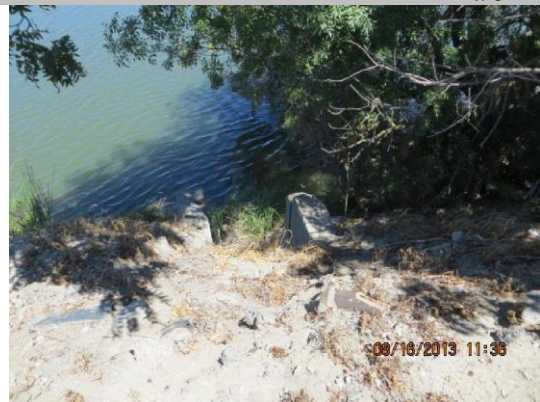
Photo 1 of 2 : UCIP_SP_2019_17575_29736.jpg

Concrete headwall visible on WS slope.

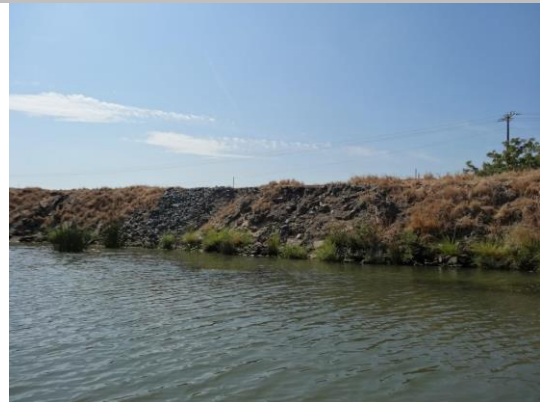
Photo 1 of 3 : SP_2019_RD0524_107_33_20190313_00051.jpg

LM Start	1.02	Rating **	U	Issue No.	33
LM End	1.02	Issue Type +	Ma	Location *	WS
Category	Supplemental			GPS Latitude/Longitude	
				Start	End
Item	DWR Erosion Survey			37.935078 °	37.935078 °
				-121.331134 °	-121.331134 °
DWR ID	RD0524U01RM41.59				
Comment Code					
Inspector Comment					
09/13/2017: No significant change observed.					
07/25/2016: No significant change observed.					
06/24/2015: No significant change observed.					
06/19/2014: No significant change observed.					
08/13/2013: No significant change at this site.					
08/07/2012: The site has been visited by boat survey. Site has been repaired, but new erosion occurred at the levee slope and immediately upstream of the repaired site.					
08/23/2011: The site is about 500 ft downstream of bridge. The levee toe seems to be protected, but the protection is being washed away.					
[2017 Site ID:RD0524U01RM41.59]

Upstream view of the site.

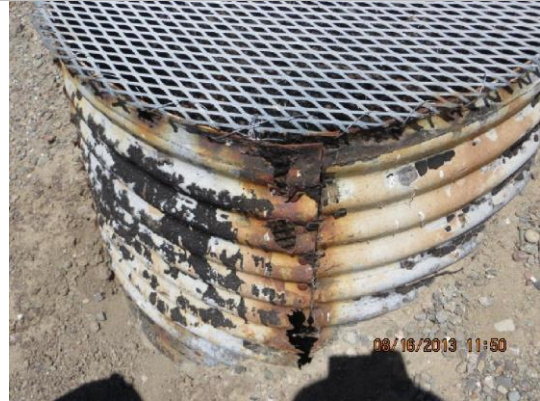
Photo 3 of 3 : UCIP_SP_2019_17589_29746.jpg

36-inch CMP riser on LS slope severely corroded with various holes along seams.

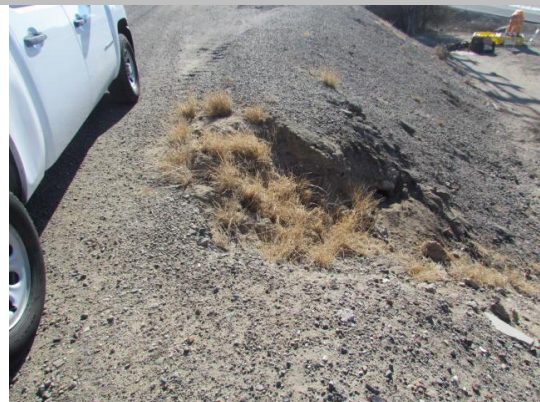
Photo 1 of 2 : SP_2019_RD0524_107_18_20190313_00026.jpg

Looking south at caving on landward shoulder. (Fall 2015)

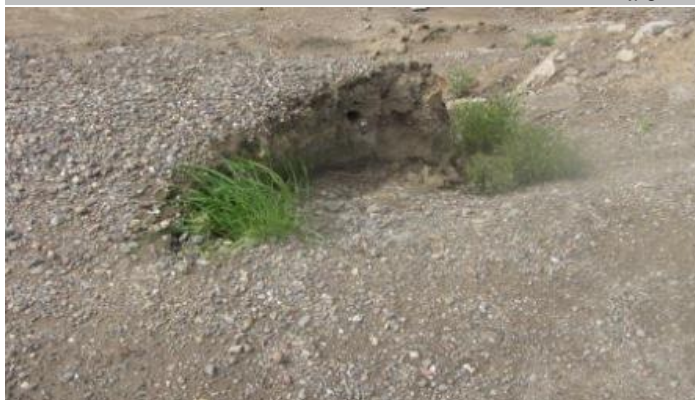
Photo 2 of 2 : SP_2019_RD0524_107_18_20190313_00027.jpg

Updated view from above the slope stability.

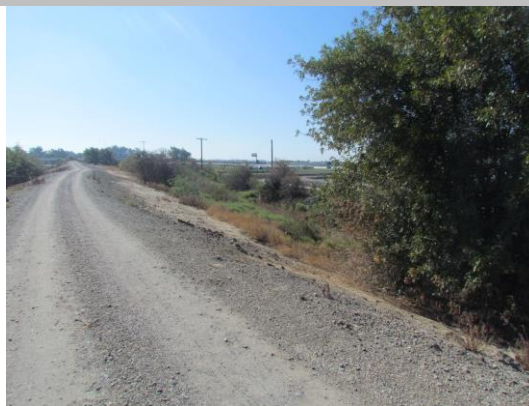
Photo 1 of 1 : SP_2019_RD0524_107_915_20190313_000284.jpg

Looking southwest at dense veg at landward toe and berm. (Fall 2016)

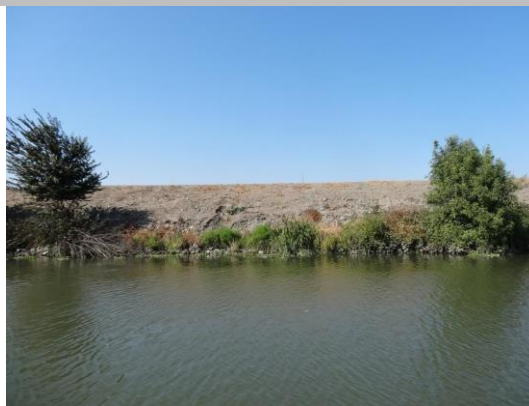
Photo 1 of 3 : SP_2019_RD0524_107_56_20190313_00077.jpg

Front view of the erosion.

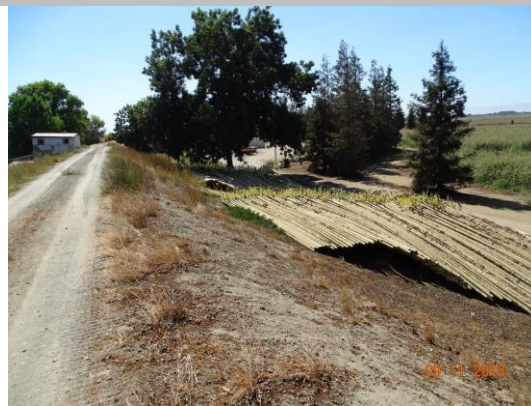
Photo 1 of 1 : SP_2019_RD0524_107_46_20190313_00065.jpg

Looking southwest at irrigation pipes stored at landward slope and toe.
(Fall 2018)

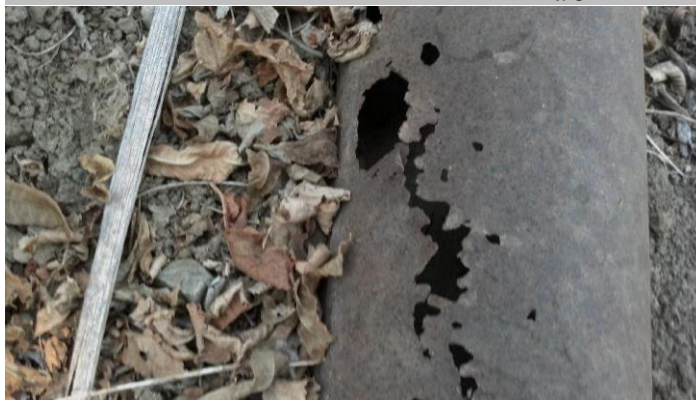
Photo 2 of 2 : UCIP_SP_2019_21883_37133.jpg

Holes in pipe along exposed side of pipe at WS slope.

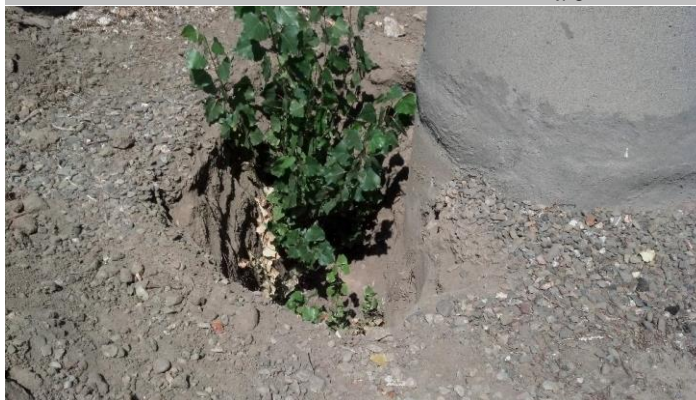
Photo 3 of 3 : UCIP_SP_2019_17944_30043.jpg

Hole over pipe next to 4-foot diameter concrete standpipe on WS slope.

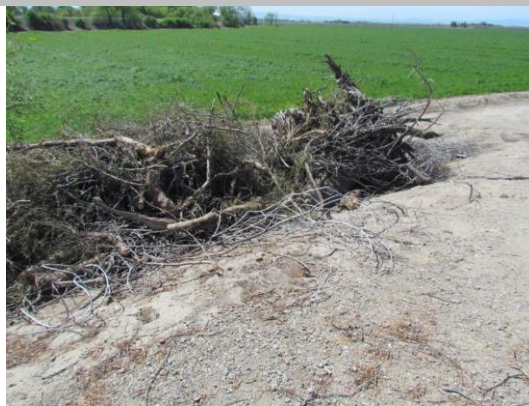
Photo 1 of 1 : SP_2019_RD0524_107_203_20190313_00211.jpg

Looking west at pruning pile on waterward slope.

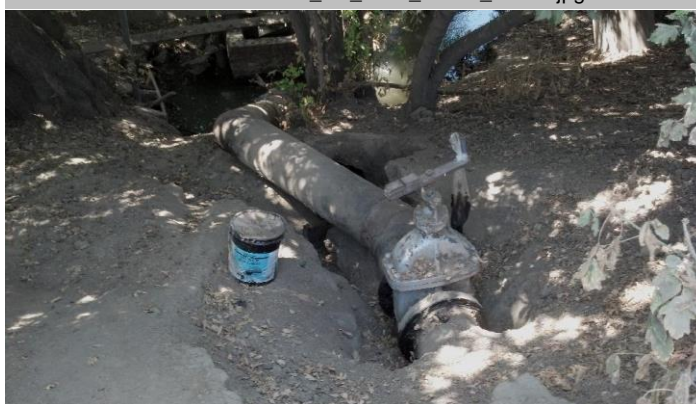
Photo 2 of 3 : UCIP_SP_2019_53357_30205.jpg

Pipe, gatevalve, and erosion on LS slope.

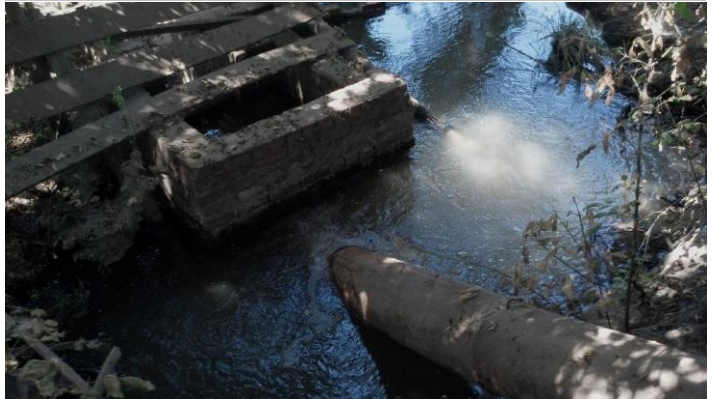
Photo 3 of 3 : UCIP_SP_2019_53357_30204.jpg

Extensive erosion around distribution box at LS toe.

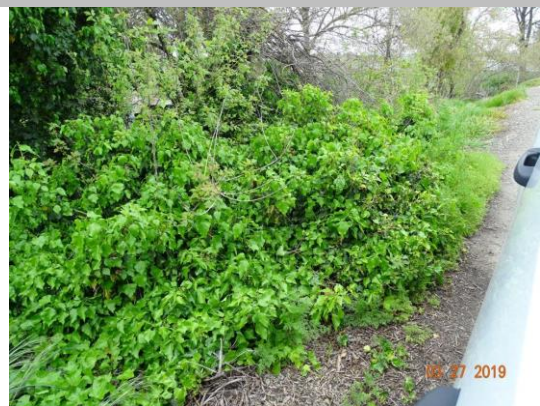
Photo 1 of 1 : SP_2019_RD0524_107_136_20190328_00393.jpg

Dense landscape vegetation on landside slope. Spring 2019.

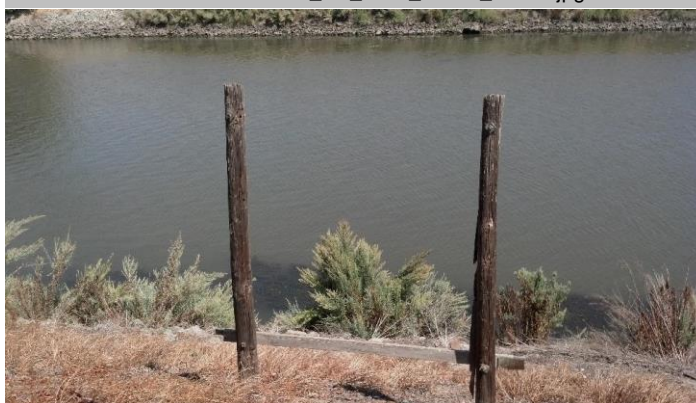
Photo 1 of 2 : UCIP_SP_2019_41464_30543.jpg

Sign posts with sign removed on WS slope.

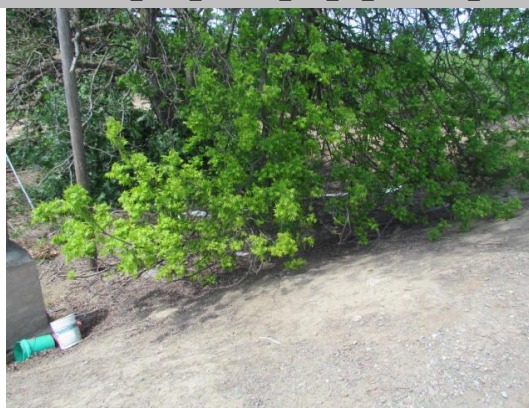
Photo 1 of 1 : SP_2019_RD0524_107_61_20190313_00087.jpg

Looking east at untrimmed tree at landward toe.

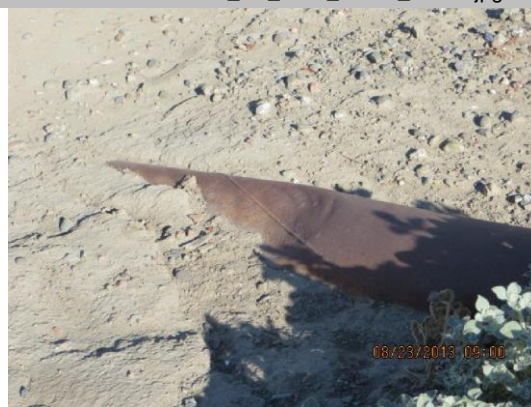
Photo 3 of 3 : UCIP_SP_2019_18320_30592.jpg

Pipe partially crushed at LS toe.

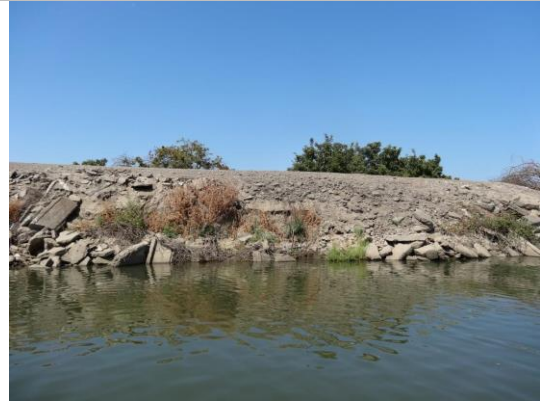
Photo 3 of 3 : SP_2019_RD0524_107_90_20190313_00122.jpg

Front view of the site. Note the loosely placed concrete blocks at the site.

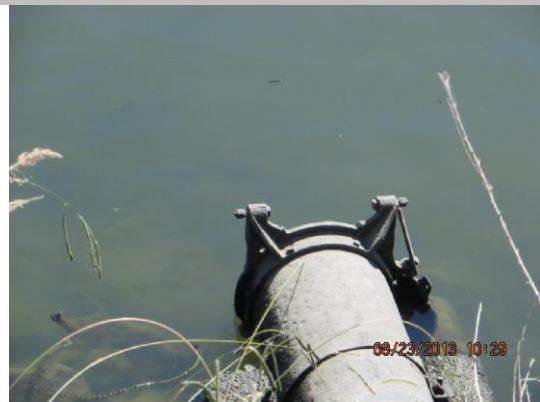
Photo 3 of 3 : UCIP_SP_2019_53358_30687.jpg

Broken flap gate at WS toe.
